SPOFFORD LAKE DAM

NH 00356

PHASE I INSPECTION REPORT  
NATIONAL DAM INSPECTION PROGRAM

NOVEMBER 1978

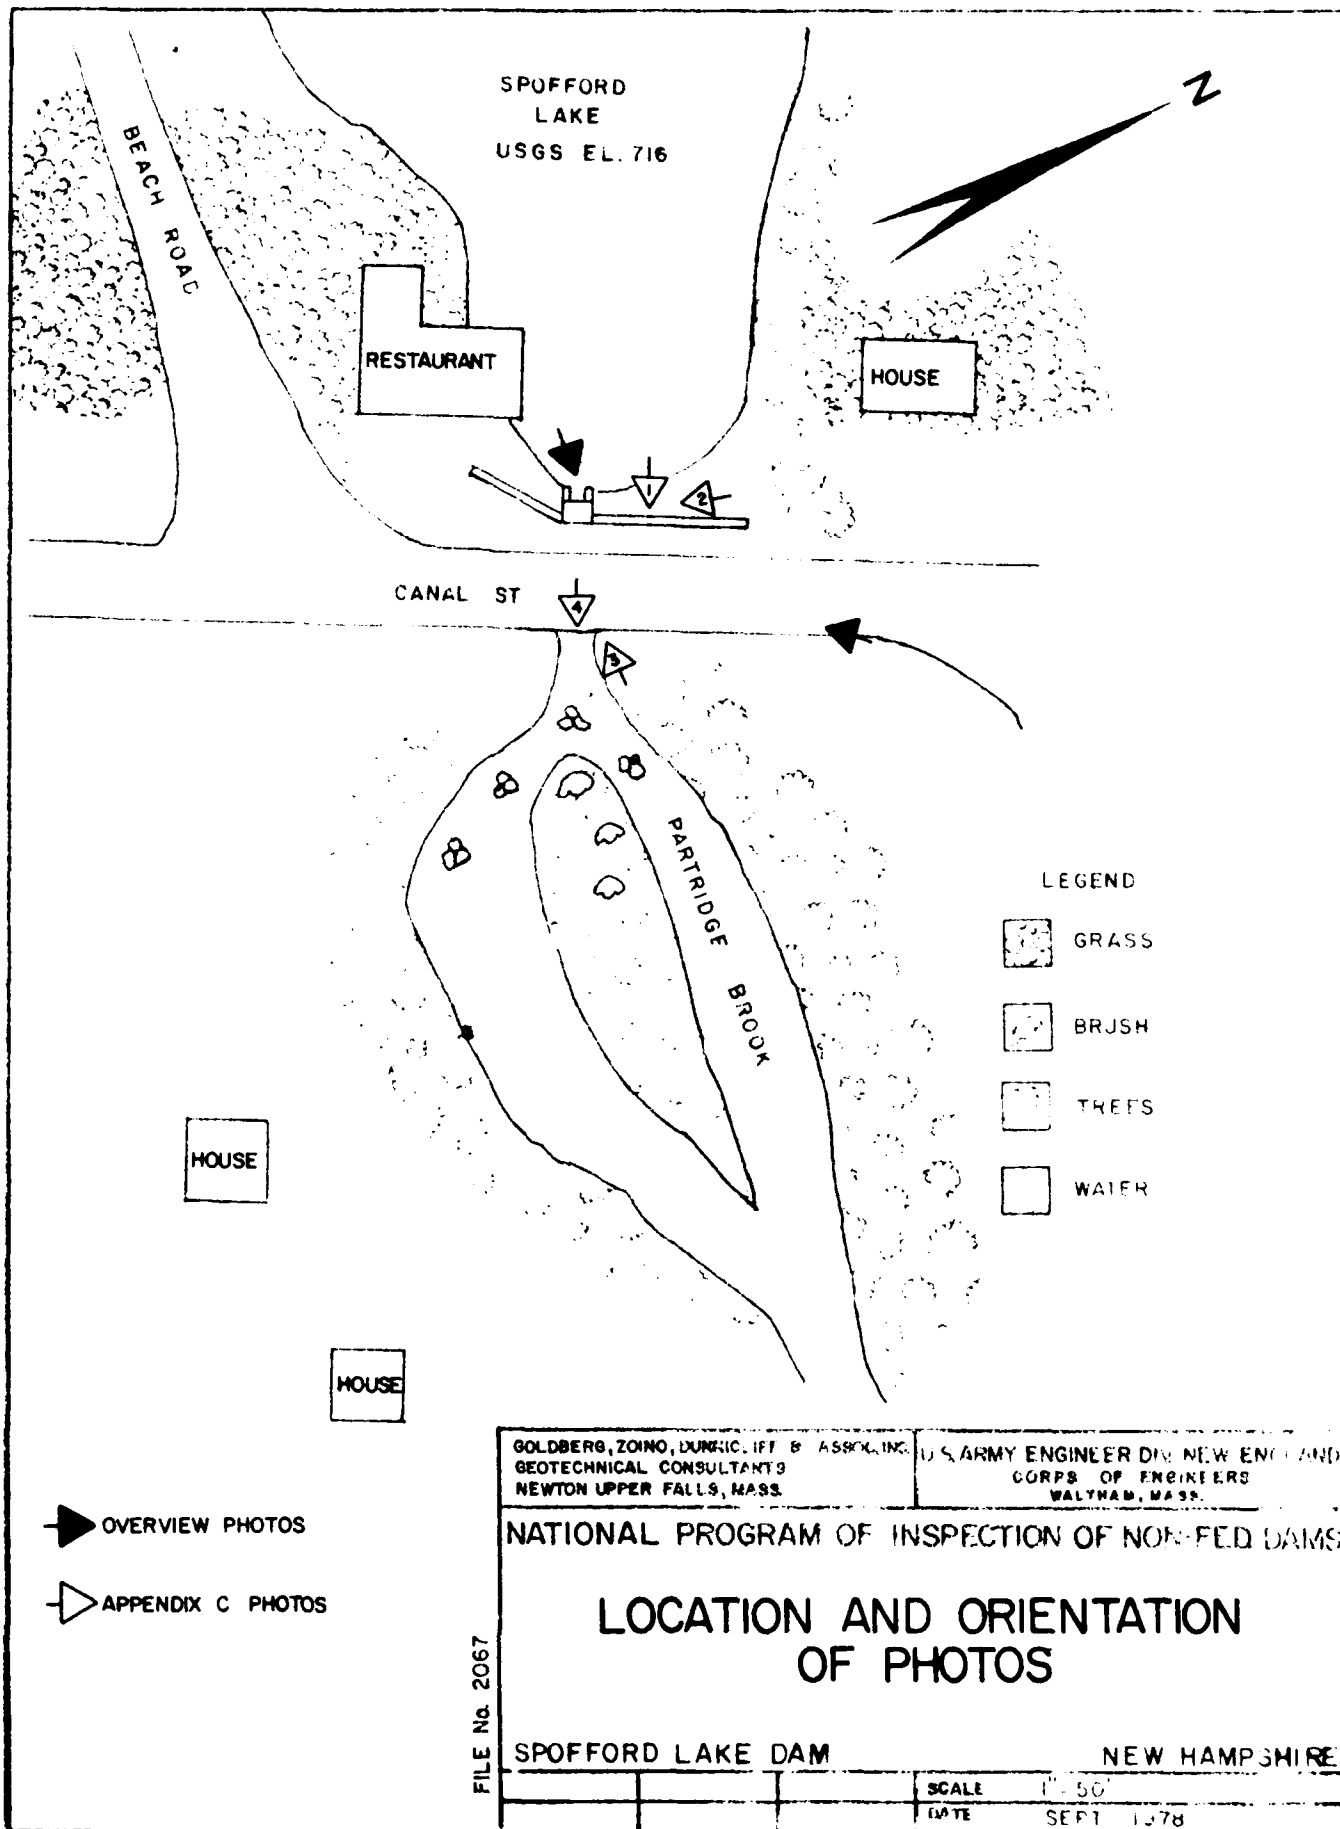
1. View of upstream concrete wall showing deterioration of concrete

The dam is in FAIR condition at the present time and requires some routine maintenance. Included in these O & M procedures are repair of deteriorated concrete, repair of erosion, removal and trimming of vegetation on the earth fill and in the downstream channel, removal of the inoperative sluice gate, cleaning of the concrete culvert, installation of a gage, institution of a formal record of operations and lake levels and establishment of an ongoing preventative maintenance program.
